HUMAN FACTORS EVALUATION OF THE SINCGARS ICOM RADIO

Richard L. Palmer

U.S. Army Research Institute
Fort Hood Field Unit

April 1987

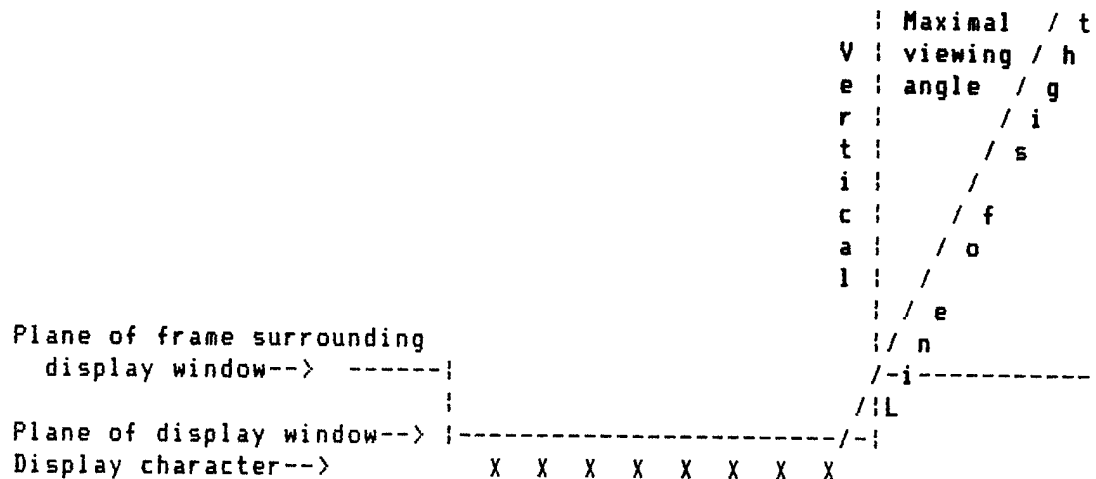
2.01 **OBSERVATION:** The maximal viewing angles for the ICOM display were measured by taking the angle between a vertical line from the plane of the display frame at the edge of the display window and a line of sight in the horizontal plane slanting away from the vertical line to the point where the edges of the characters began to be occluded from view, as in the following illustration for viewing the display from the right side:

The maximal viewing angles determined by this method were the following (they are approximate):

- 30 degrees from the top of the display
- 27 " bottom "
- 30 " right "
- 30 " left "

IMPACT: The nominal maximal viewing angles are improved over the non-ICOM radio (for which they were approximately 12 degrees above and below, 20 degrees to the left, and 25 degrees to the right). The improvement is, however, much greater than the nominal values would indicate because of the change from a five-character, seven-segment LED to an eight-character (seven used), 5 x 7 dot matrix LED. The dot matrix allows much greater detail in the display characters, thus making them considerably more distinct from one another even if the entire character is not visible because of extreme viewing angle. Furthermore, the first and eighth characters of the display (which graphically indicate signal strength and low battery condition, respectively) are not used for alphabetical or numerical messages, and the seventh character is not used at all; therefore the effective readability of the display (for alphanumeric prompts and feedback) from extreme side-viewing angles is greater than that indicated by the nominal values given. When the first, seventh, and eighth characters are not considered, the effective angles for viewing from the left and right are approximately 62 and 82

degrees, respectively. Thus, while the top and bottom angles are still somewhat restricting, the side angles are not.

COMMENTS/POSSIBLE IMPROVEMENTS: The fact that the display characters are considerably inset from the surface of the display limits the maximal viewing angles. Design efforts should attempt to minimize this inset. The bottom viewing angle (27 degrees) could possibly be widened by tapering the top edge of the frame around the keypad. (Of course, nighttime security considerations tend to work in opposition to viewing considerations, and in some situations there may be reasons to minimize rather than maximize viewing angles.)
